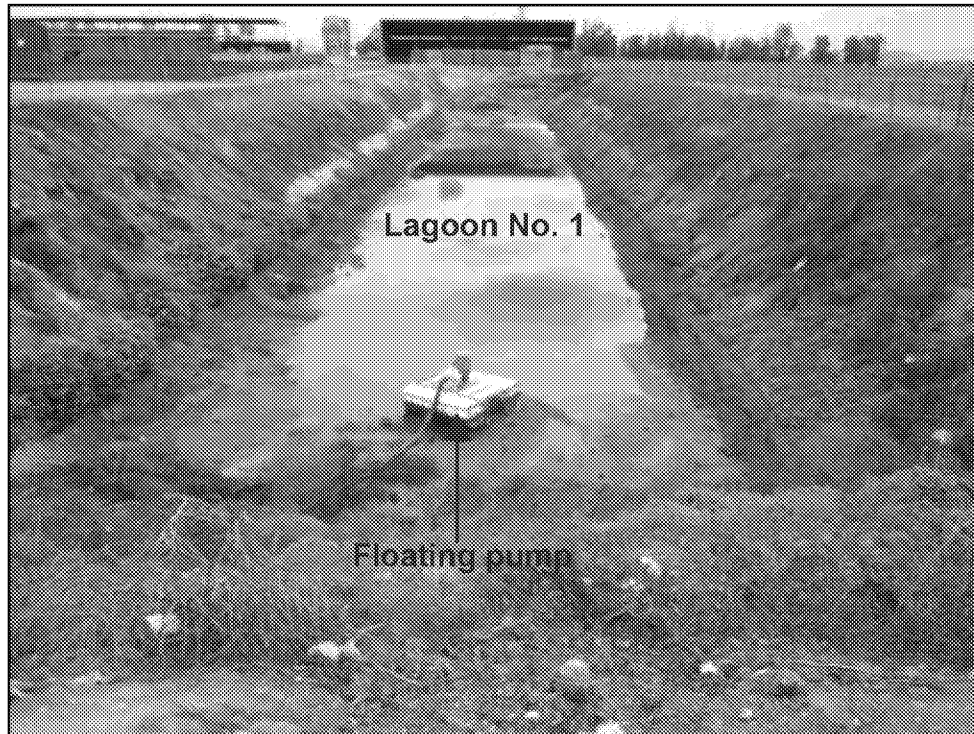
1. A depth marker was not installed in lagoon No. 1, located in the central portion of the Facility as required by Permit Attachment B - Monitoring and Reporting Program, Section I.B.1 (refer to Photo 2). This is a recurring issue identified in a previous inspection conducted on October 23, 2008.

The Facility is an 80-acre dairy farm with an animal population of approximately 1,100 milking cows, 153 dry cows, 55 heifers, and 17 bulls at the time of the inspection. Process wastewater from milking and cow washing activities is collected into a sump on the south side of the milking barn. Process wastewater collected in the sump is gravity-fed west and south to a series of standpipes located in pasture Nos. 1, 2, and 3 (refer to Photos 3 and 4). According to Mr. Romero, all process wastewater from cow washing activities is piped to the Facility pastures for land application. At the time of the inspection, process wastewater water from the milking barn was being land applied onto pasture No. 2 via alfalfa valves (refer to Photos 4 and 5). Mr. Romero stated that the alfalfa valves are rotated twice a day and that all process wastewater lines are flushed every 3-4 days. All excess storm water runoff from the pastures and water from land application activities naturally flows to the southwest corner of the Facility to catch basin No. 1 (refer to Photo 6). A return flow system equipped with a sump pump is located in the southwest corner of the Facility, and is utilized to recycle water from catch basin No. 1 back to the standpipes located in pastures Nos. 1, 2, and 3 (refer to Photos 6, 7, and 8). Mr. Romero stated that the return sump pump is serviced monthly and that all solids that accumulate in the pastures and catch basin are removed twice per year. A concrete spillway was observed in the southwest corner of the Facility, adjacent to Merrill Avenue (refer to Photo 9). All storm water runoff from the corrals is collected into lagoon No. 1 (refer to Photos 2 and 10). Storm water runoff from corral Nos. 1 through 10 flows into the central cow lane located between the corrals, then south, via sheet flow, into lagoon No. 1 (refer to Photos 10 through 13). The north-central portion of lagoon No. 1 is concrete-lined to prevent erosion from sheet flow (refer to Photos 12 and 13). Storm water runoff from corral Nos. 11 through 19 flows south along the western perimeter of the corrals, then east into lagoon No. 1. Mr. Romero stated that lagoon No. 1 only collects storm water runoff from the corrals and milking barn area and that the lagoon is cleaned every October. The lagoon appeared well-maintained at the time of the inspection; however, a depth marker had not been installed in the lagoon (refer to Photo 2).

1. The inspector observed, during the inspection, that a depth marker was not installed in lagoon No. 1 located in the central portion of the Facility as required by the Permit (refer to Photo 2). This is a recurring issue identified in a previous inspection conducted on October 23, 2008. Permit Attachment B - Monitoring and Reporting Program, Section I.B.1 states that "a marker shall be placed within each pond or impoundment to indicate the minimum capacity necessary to contain the runoff and direct precipitation of the 25-year, 24-hour rainfall event."

**Photograph 2.** View facing east of lagoon No. 1 located in the central portion of the Facility. Note the lagoon did not contain a depth marker.

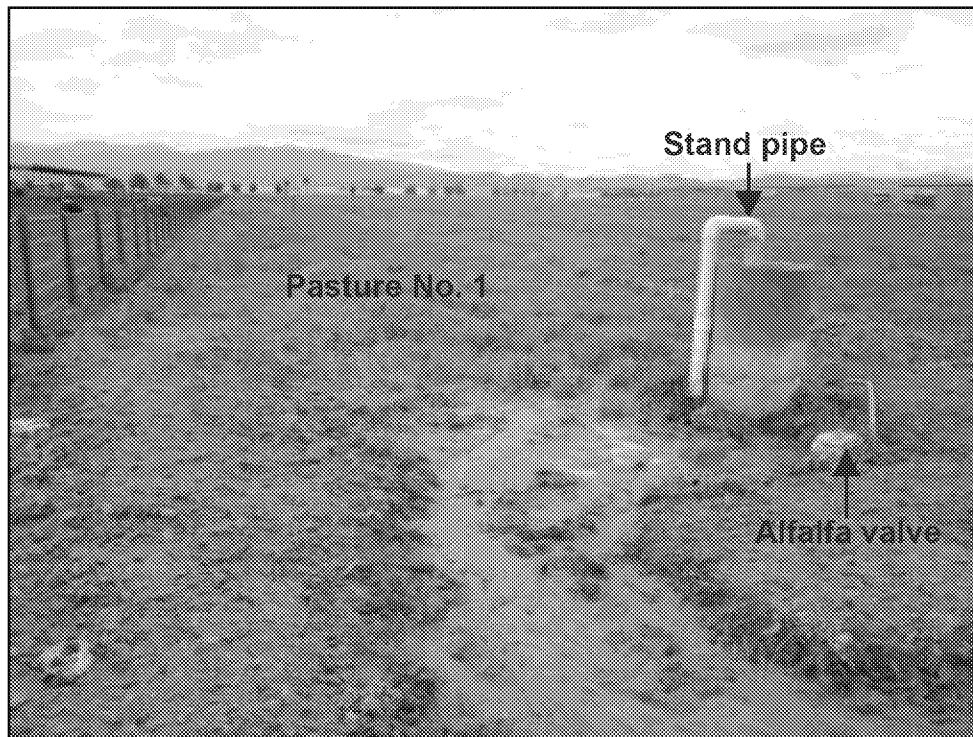
4. The EWMP was not fully implemented onsite at the Facility at the time of the inspection, as required by Provision VII.C.3.b of the Permit (refer to Photos 2 through 7).

3. The EWMP was not fully implemented onsite at the Facility as required by the Permit. Section V - 'Operation and Maintenance' of the EWMP requires that the Discharger "disc percolation areas (fields) to about 18 inches to assure maximum percolation during wet seasons...All of the disposal areas should be disked at least once each year." Specifically, Mr. Romero informed the inspector that the disposal pastures are not disked or plowed to promote percolation and infiltration. Provision VII.C.3.b of the Permit states that "the discharger shall develop and fully implement an Engineered Waste Management Plan (EWMP) acceptable to the Executive Officer." As a result, the Discharger was not fully implementing the approved EWMP. The Discharger shall fully implement the EWMP as required by Provision VII.C.3.b of the Permit.

**Photograph 3.** View facing south of a stand pipe located in the northeast corner of pasture No. 1. All process wastewater flows from the milking barn sump may be piped to standpipes in pastures Nos. 1, 2, and 3.

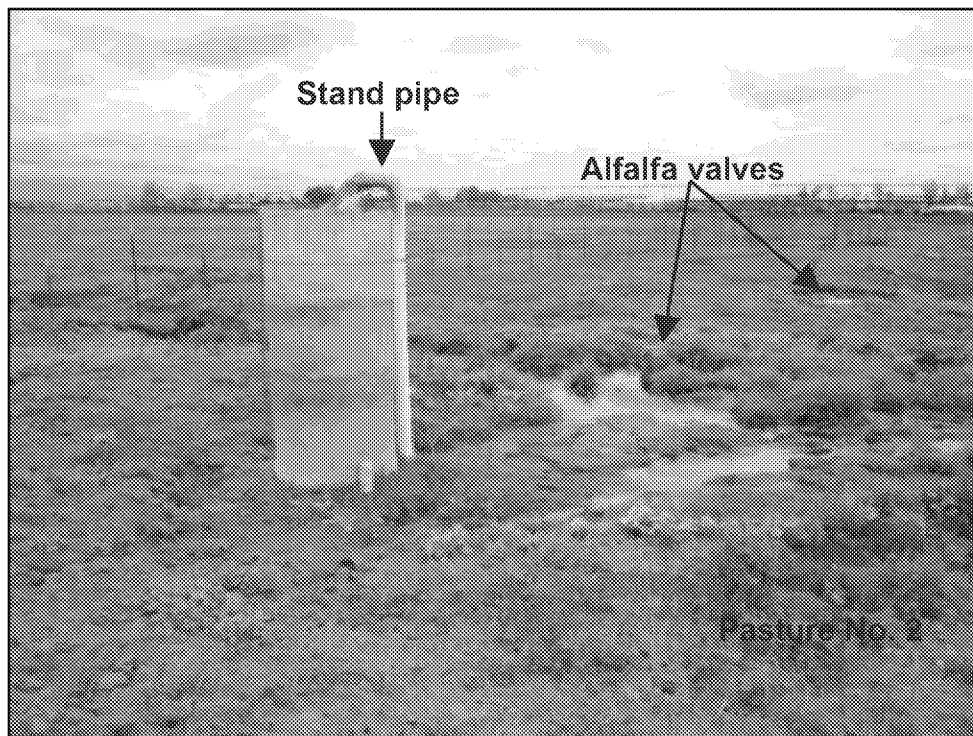
**Photograph 4.** View facing east of a stand pipe located on the north side of pasture No. 2. Note process wastewater from the milking barn was being land-applied onto pasture No. 2 at the time of the inspection.

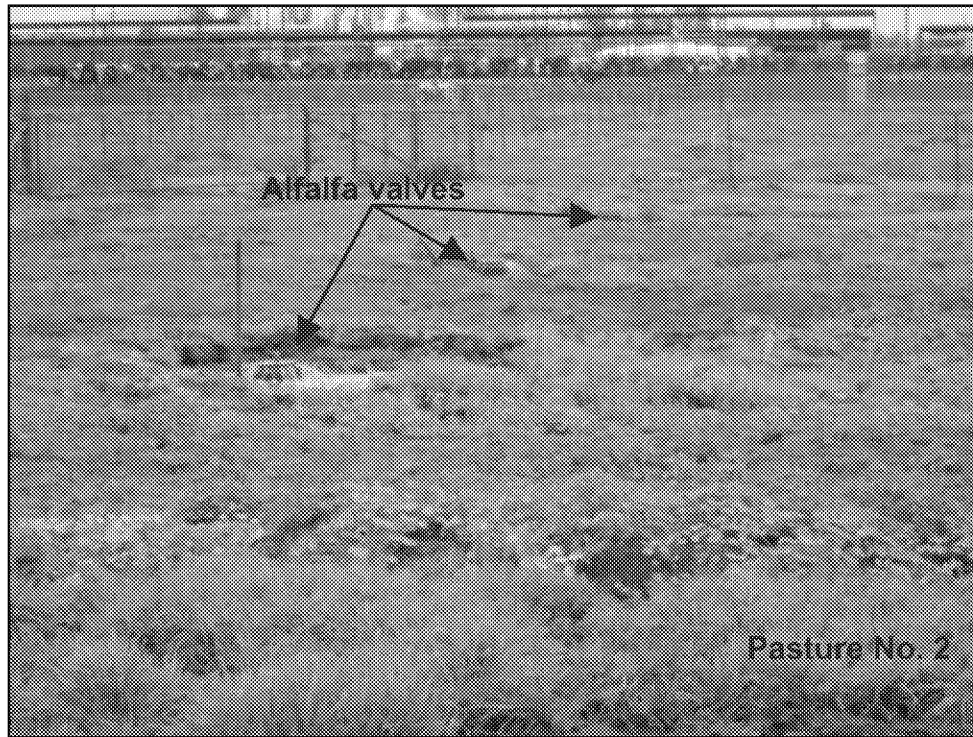
**Photograph 5.** View facing east of alfalfa valves in pasture No. 2 actively releasing process wastewater into pasture No. 2.

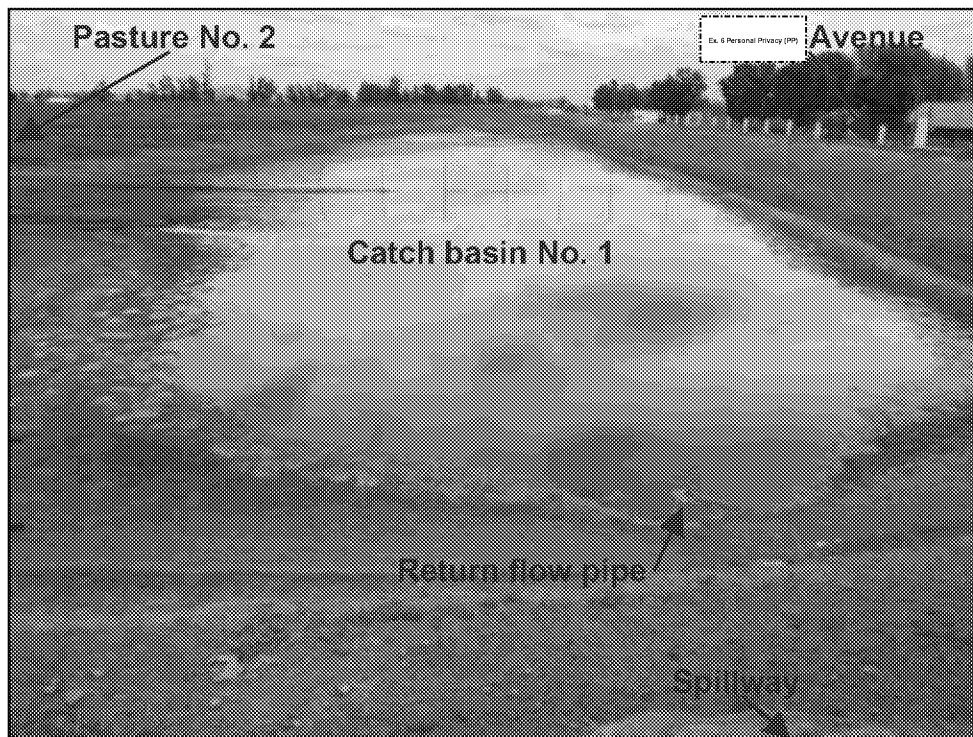
**Photograph 6.** View facing east of catch basin No. 1 located in the southwest corner of the Facility. Note wastewater from catch basin No. 1 flows into the return flow pipe and is pumped, via sump pump, to standpipes located in pasture Nos. 1, 2, and 3 for reuse, shown in Photographs 3, 4, and 5.

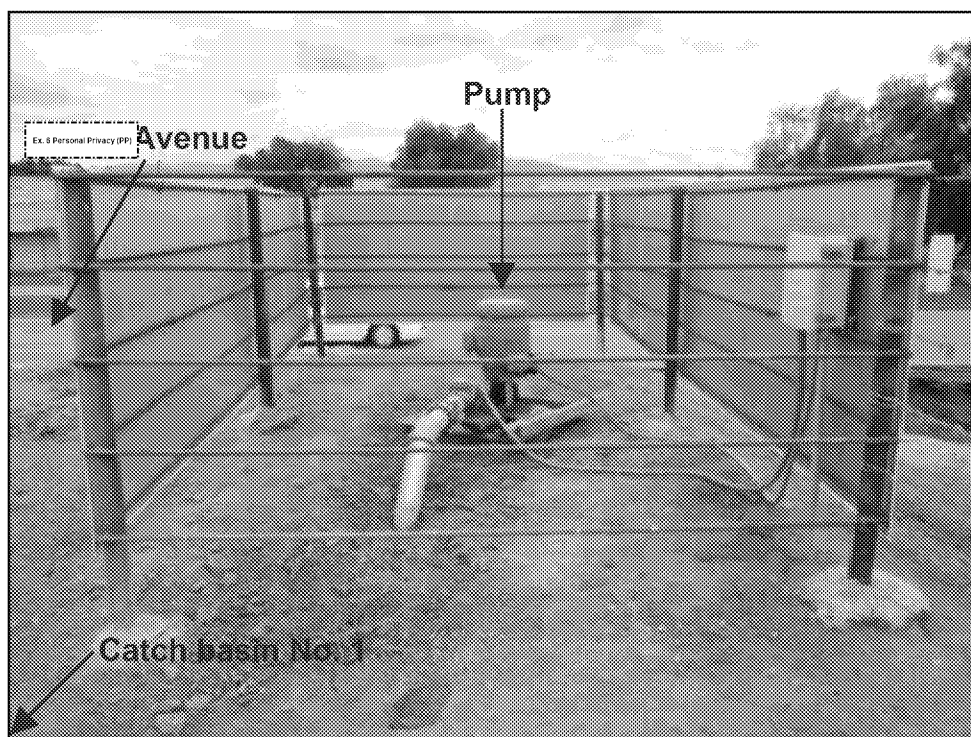
**Photograph 8.** View facing south of the return flow sump pump located in the southwest corner of the Facility, adjacent to catch basin No. 1 and Ex. 8 Personal Privacy (PP) Avenue.

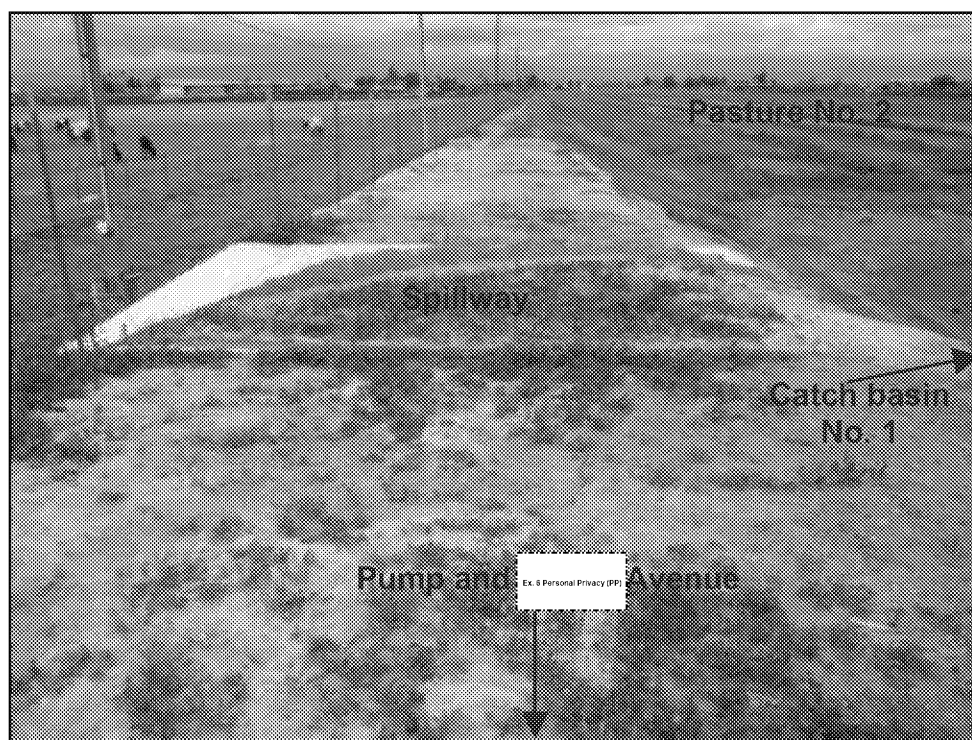
**Photograph 9.** View facing north of the concrete spillway located on the west side of catch basin No. 1, shown in Photographs 6 and 7.

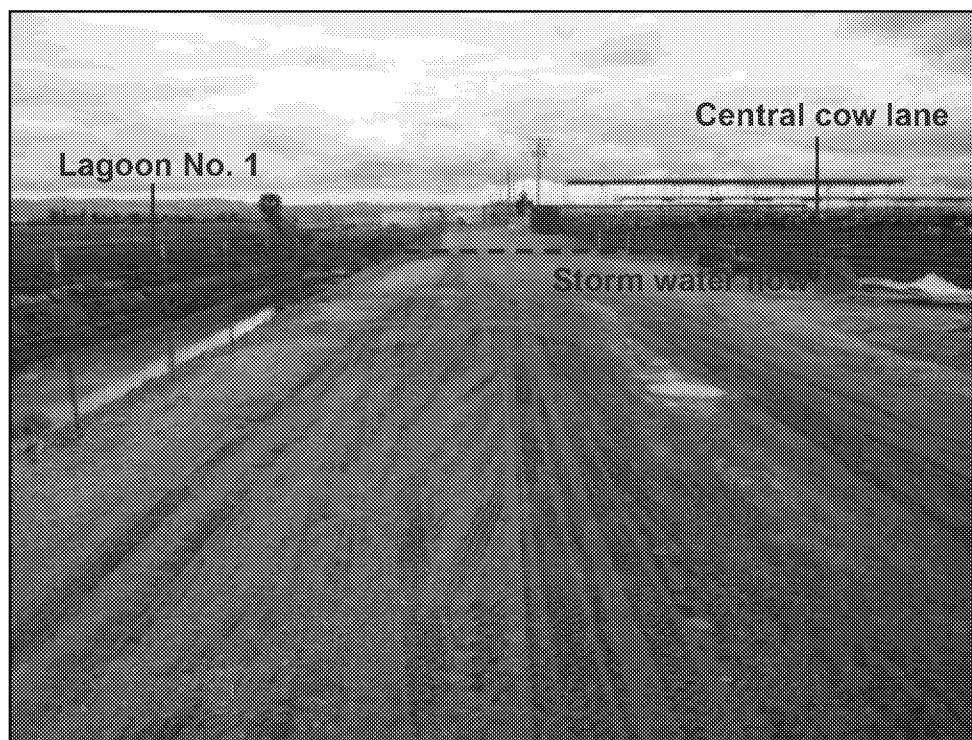
**Photograph 10.** View facing west of the storm water flow pathway from the corrals into lagoon No. 1. Note all storm water runoff from the corrals enters the lagoon via sheet flow through the central cow lane.

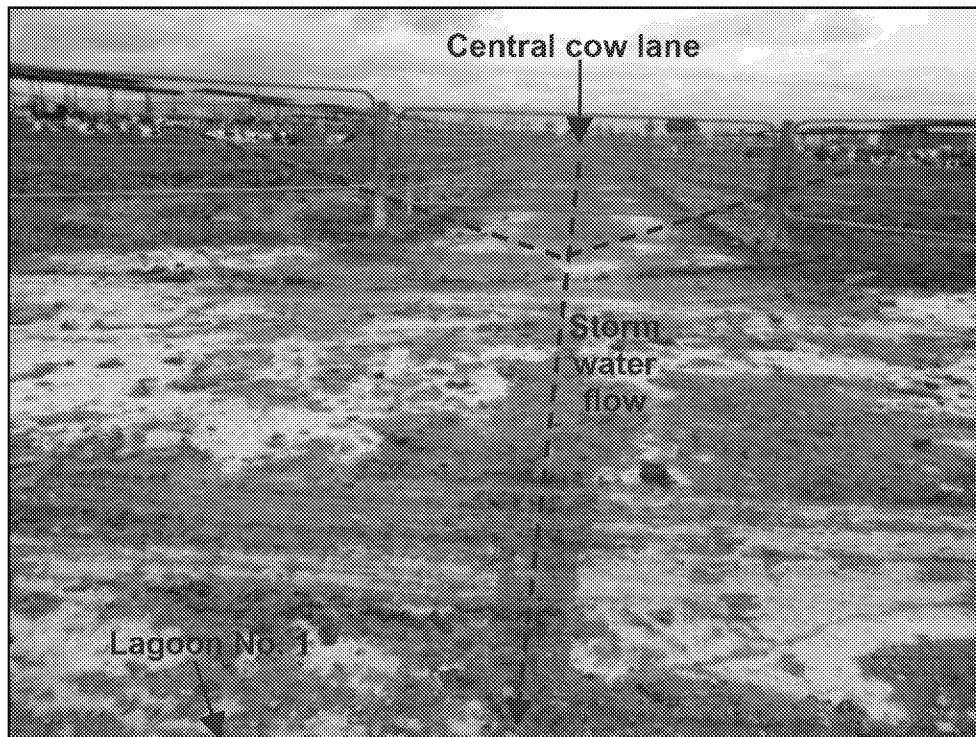
**Photograph 11.** View facing north of the central cow lane, north of lagoon No. 1. Note all storm water runoff from the corrals flows into the central cow lane, then south into lagoon No. 1.

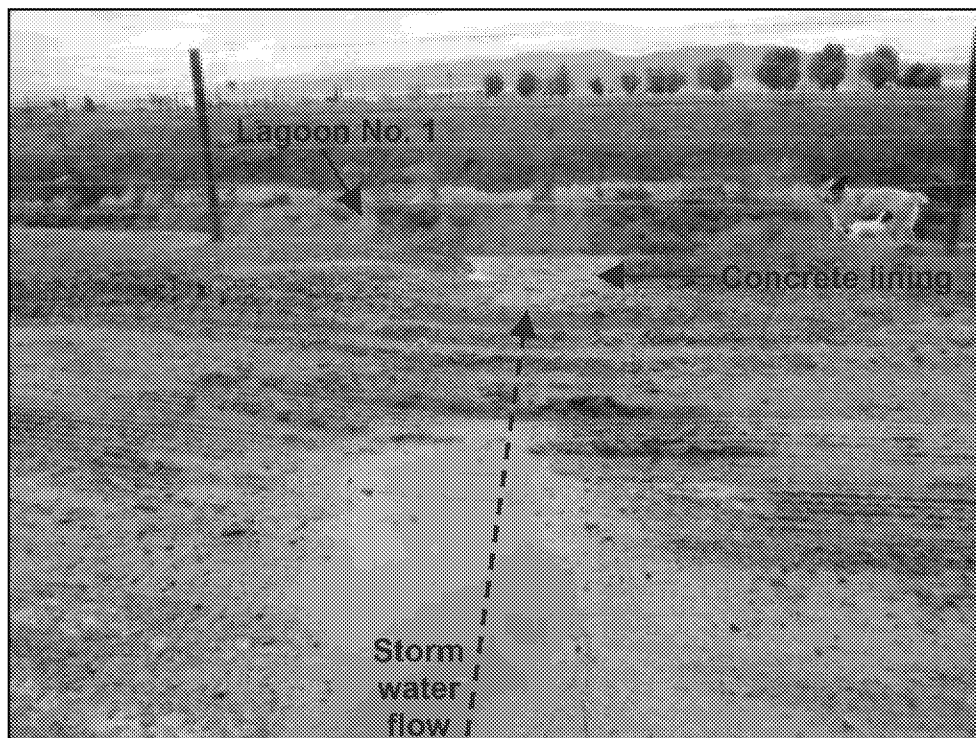
**Photograph 12.** View facing south of the storm water flow pathway from the corrals into lagoon No. 1. Note the storm water runoff entrance location on the north-central side of lagoon No. 1 was lined with concrete to prevent erosion from occurring on the embankment.

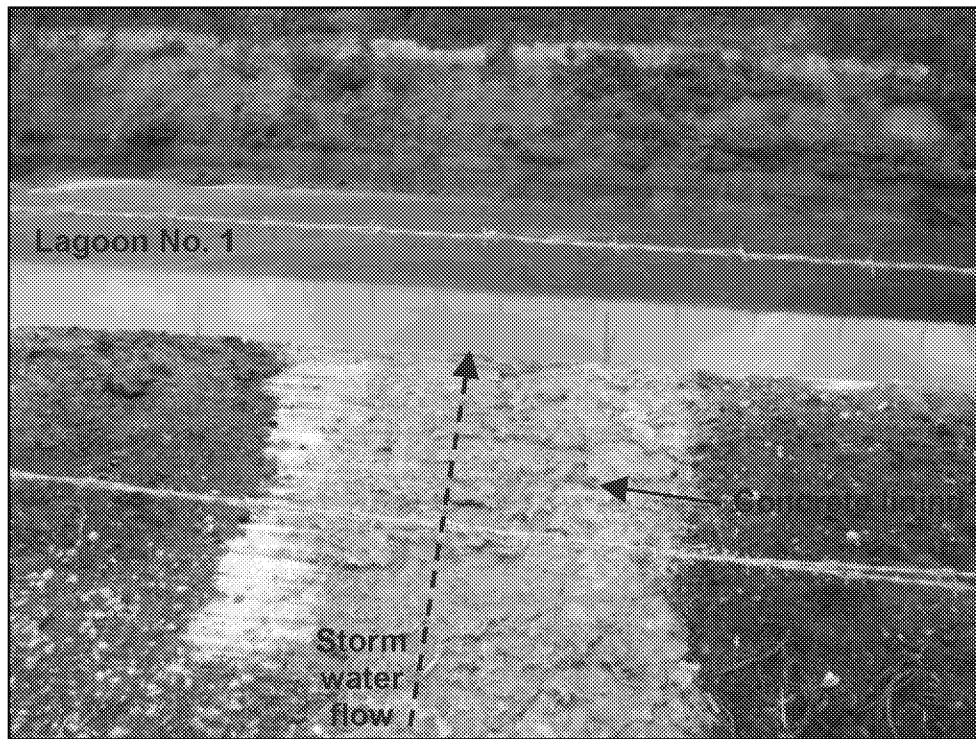
**Photograph 13.** Close-up view of the concrete-lined storm water runoff entrance location on the north-central side of lagoon No. 1, shown in Photograph 12.
